# Comparison

## Perforated Plate Belt Screen

## EscaMax

October 2009  
Franz Spenger

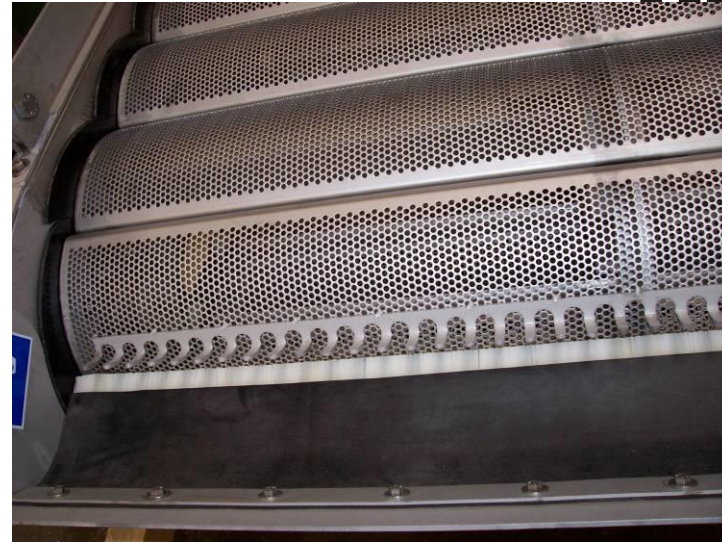
- ⇒ **EscaMax**: bottom sealing with **double** brush and neoprene
- ⇒ Riveted plastic plates sealing (separately removable) between the perforated elements and the frame
- ⇒ Bottom sealing directly combined with the screen

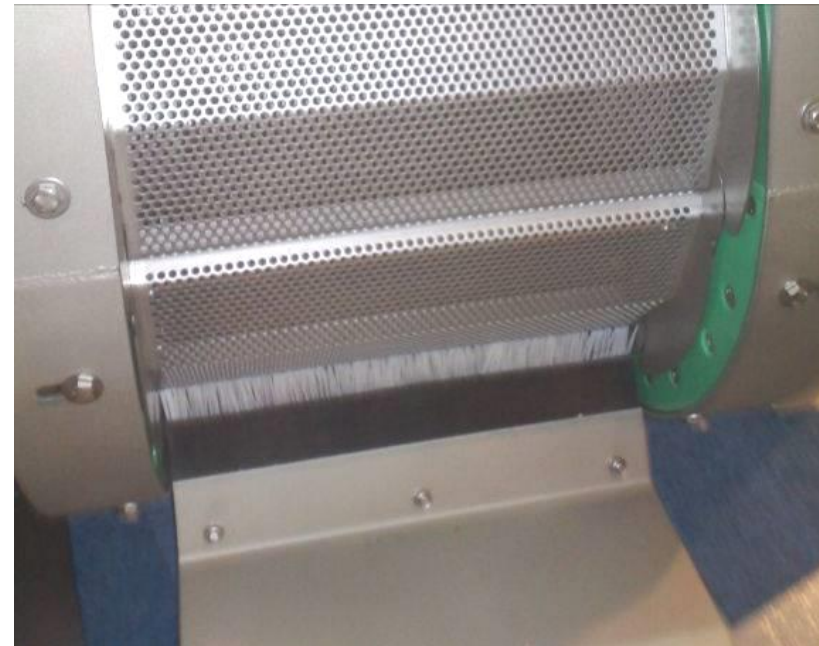
- ⇒ **competitor**  
**One** brush + neoprene on the bottom sealing
- ⇒ The elements have steel plates and plastic on the frame and are only removable as complete units!
- ⇒ Steeply rising and separate bottom plate

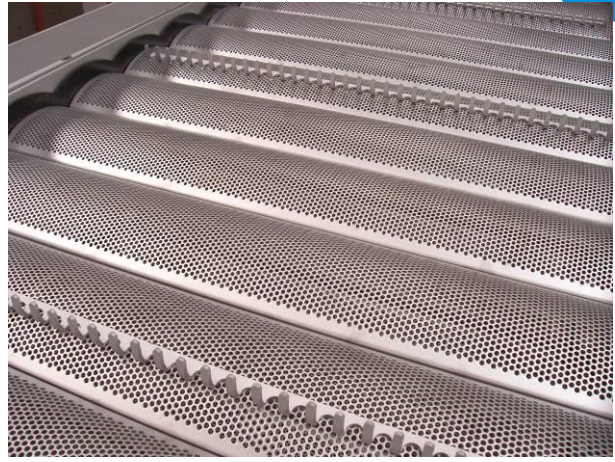
- Marginal gap between the elements
- No blocking possible due to the unperforated edge

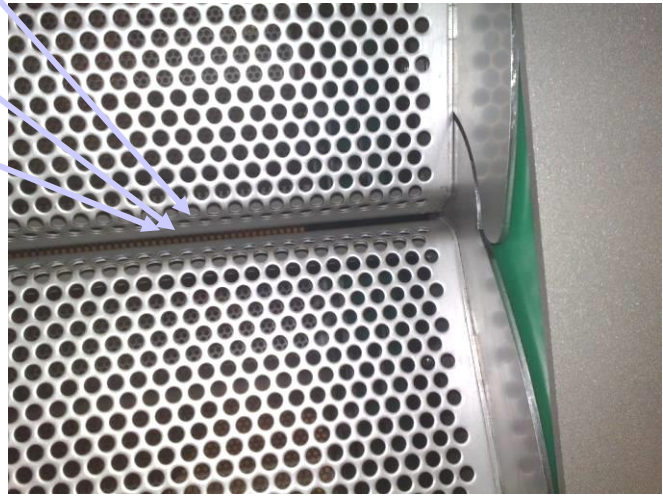
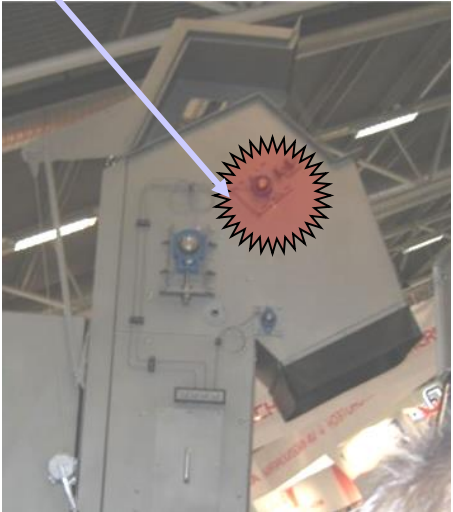
- Wide slots between the sections
- Stones could jam in the gap.
- Brush cannot clean the passage.

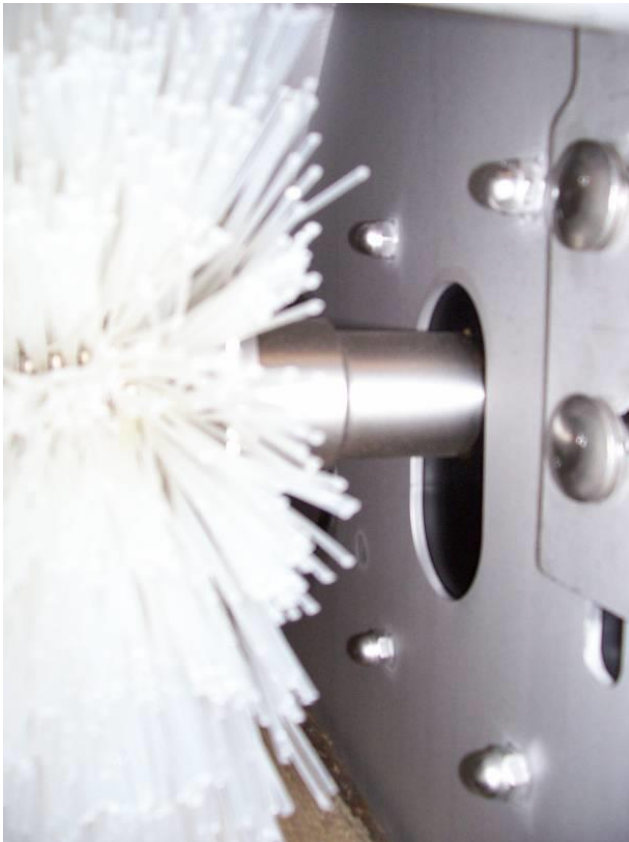
- ⇒ **EscaMax:** Additional sealing of the housing ... Spray water cannot penetrate the bearing.

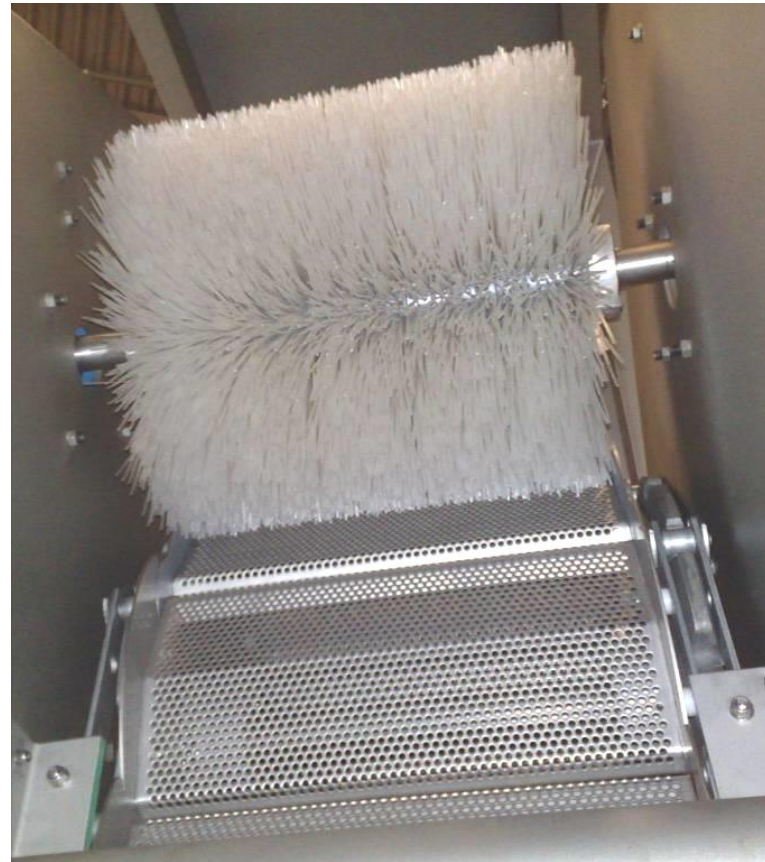
- ⇒ **competitor :** Spray water enters the bearing with the effect of ... bearing damage.

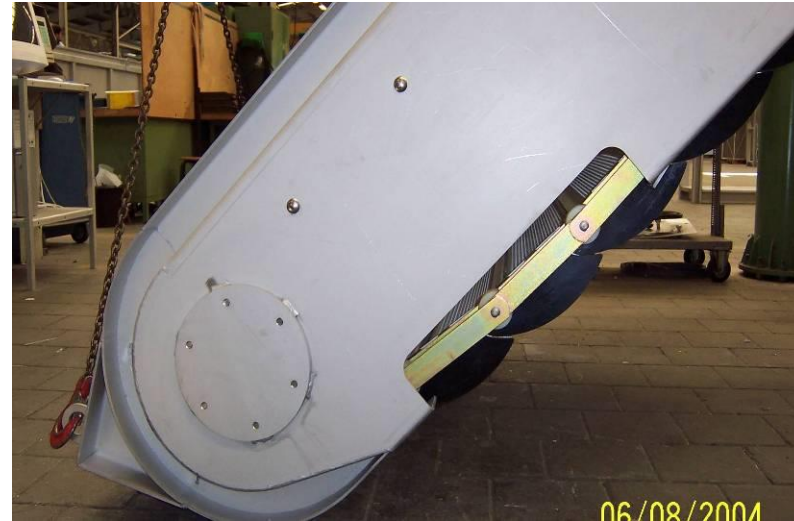
- ⇒ **EscaMax:** The opening in the back of the frame increases hydraulic throughput and avoids accumulation of screenings.

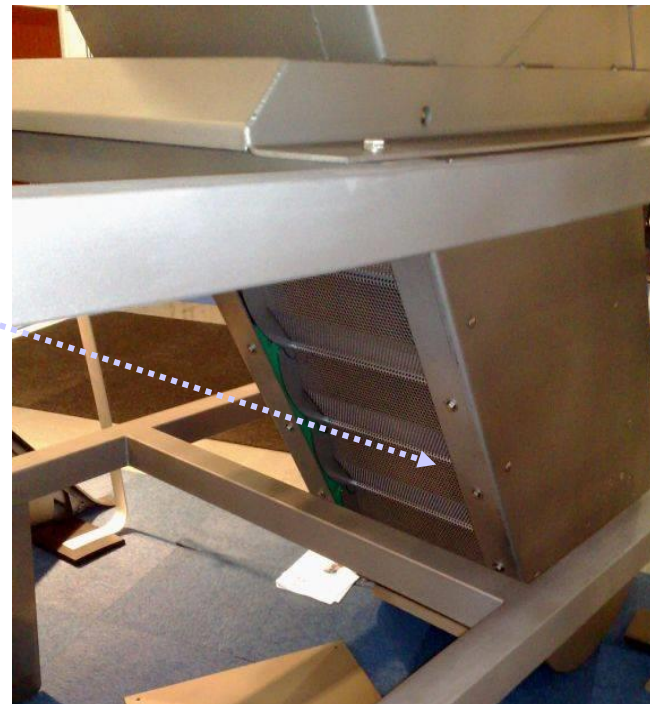
- ⇒ **competitor :** No opening in the back of the frame

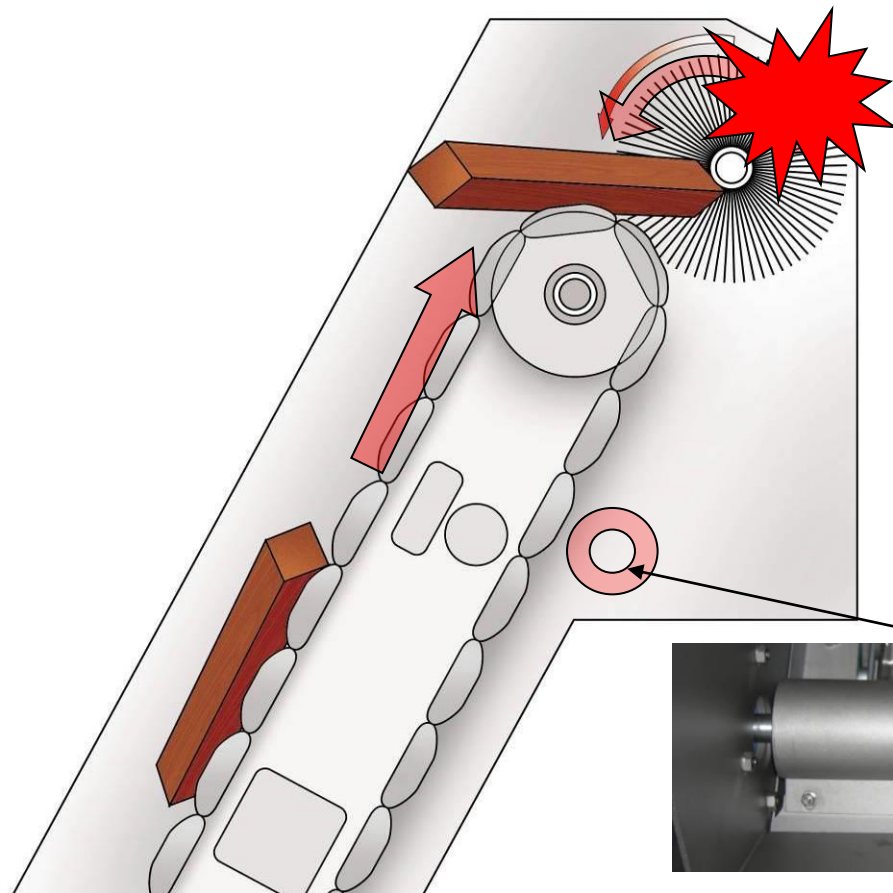
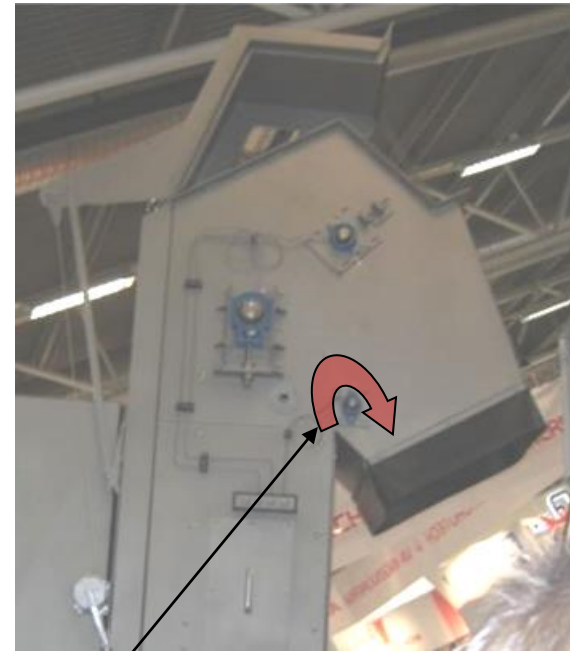
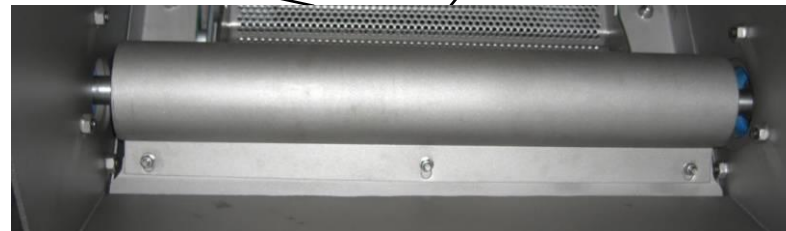
- ➔ Cleaning of the screening elements by means of a roller brush rotating in the **same direction** leads to blocking.
- ➔ The result:  
The roller brush and screening elements are damaged.

Additional rotating roller
